DETECTING EMERGING SINKHOLES WITH FWD TESTING

Carl A. Lenngren
Lund University
2014 FAA WORLDWIDE TECHNOLOG
TRANSFER CONFERENCE
6 August 2014

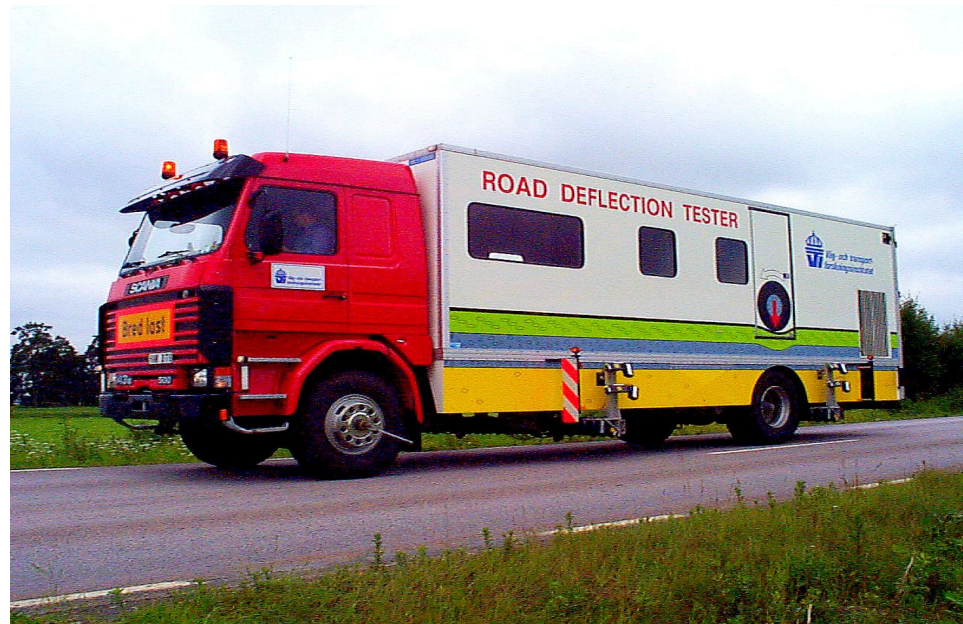
Rolling Deflectometer Tests

- During 1990:s a test of pavement dynamic response was carried out with a Road Deflection Tester.

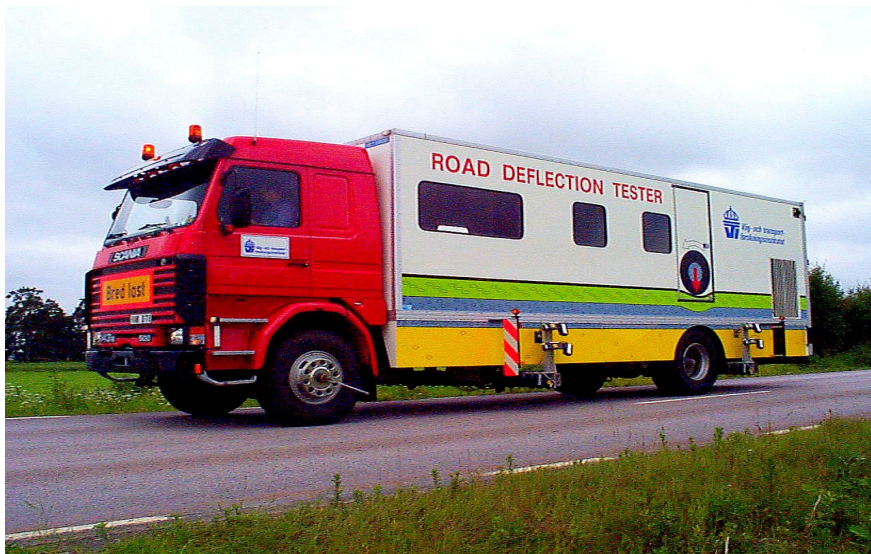
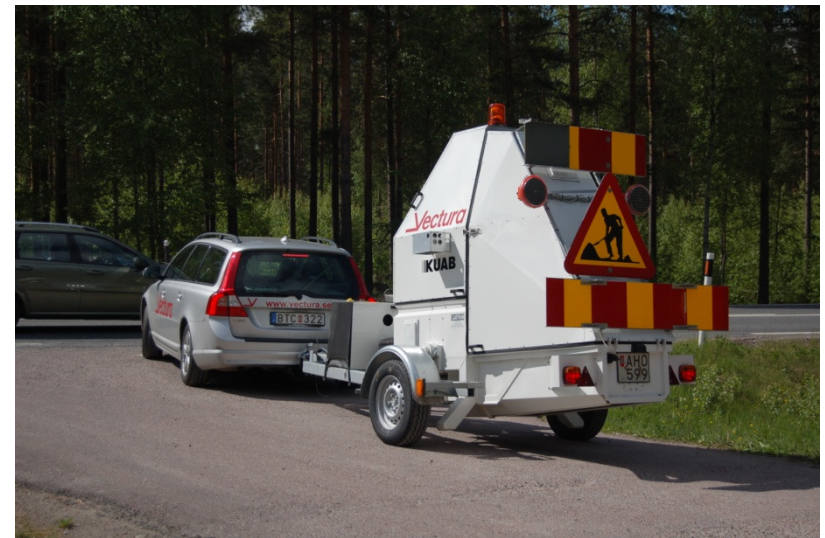
Rolling Deflectometer Tests

- The RDT was validated by Falling Weight Deflectometer Tests

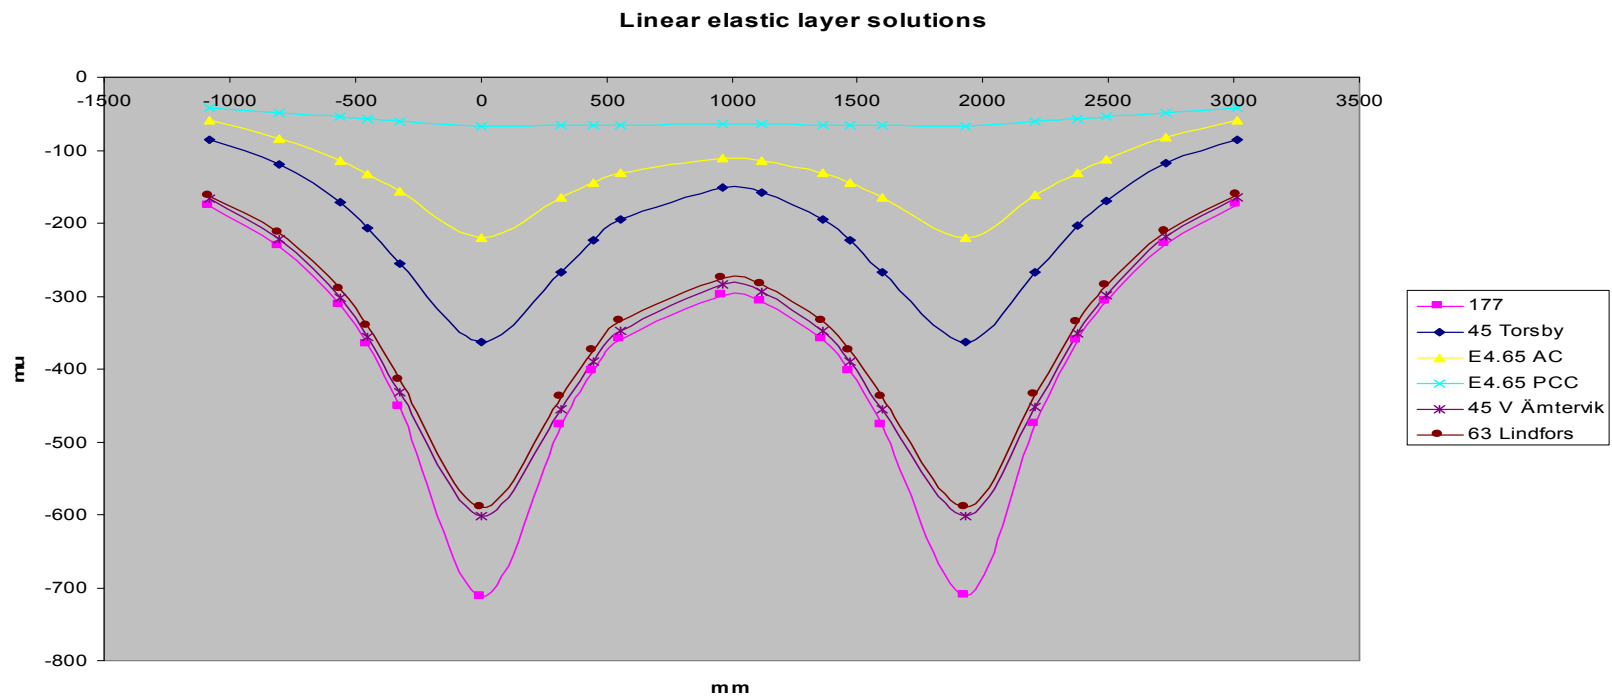
Various pavement and subgrade types. 130 Test Sections

Transverse deflection profiles from truck load

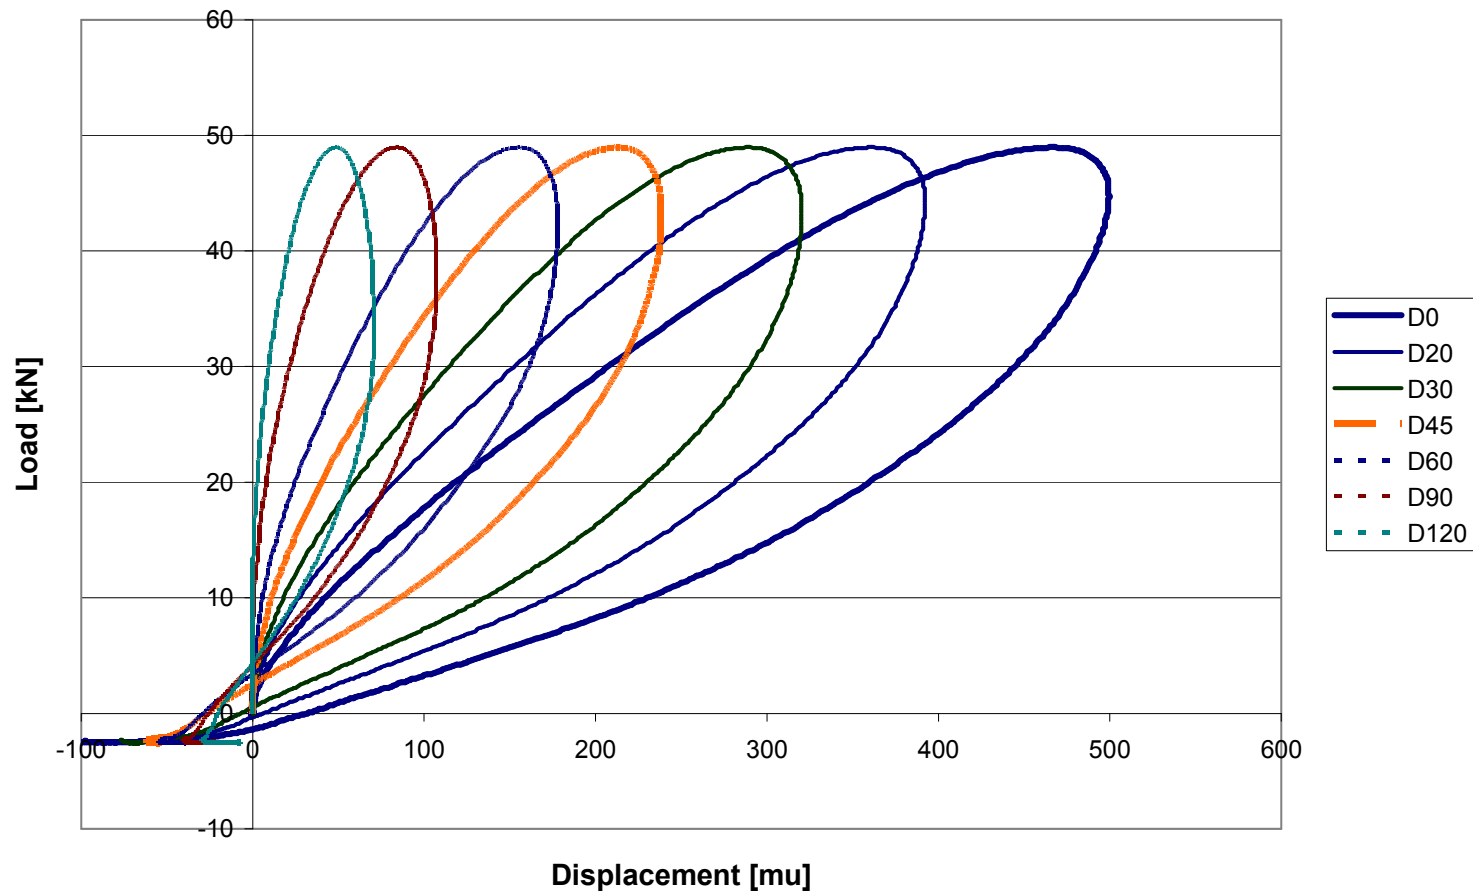
By plotting load vs. displacement
hysteresis curves are attained

Area of curve corresponds to dissipated work

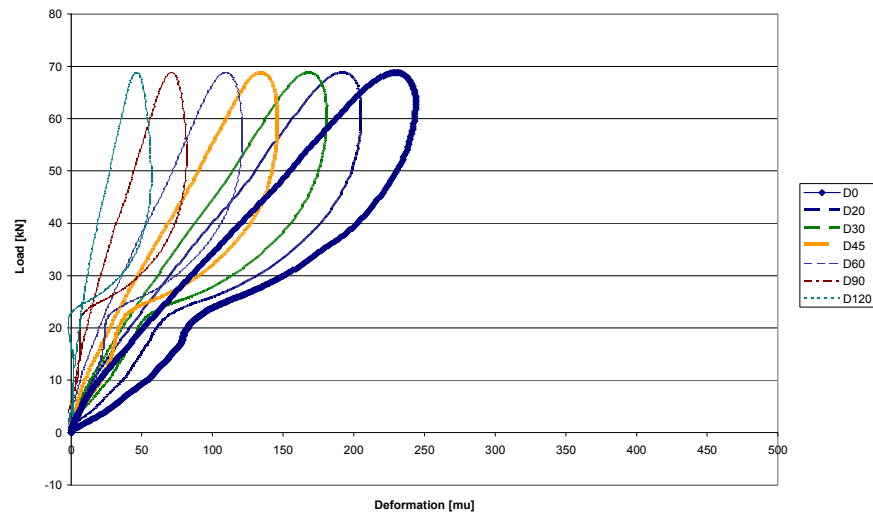
Calibration with actual truck fuel consumption tests in 2007

Flexible 4.2 Nm
@70kN

Rigid 1.04 Nm
@70 kN

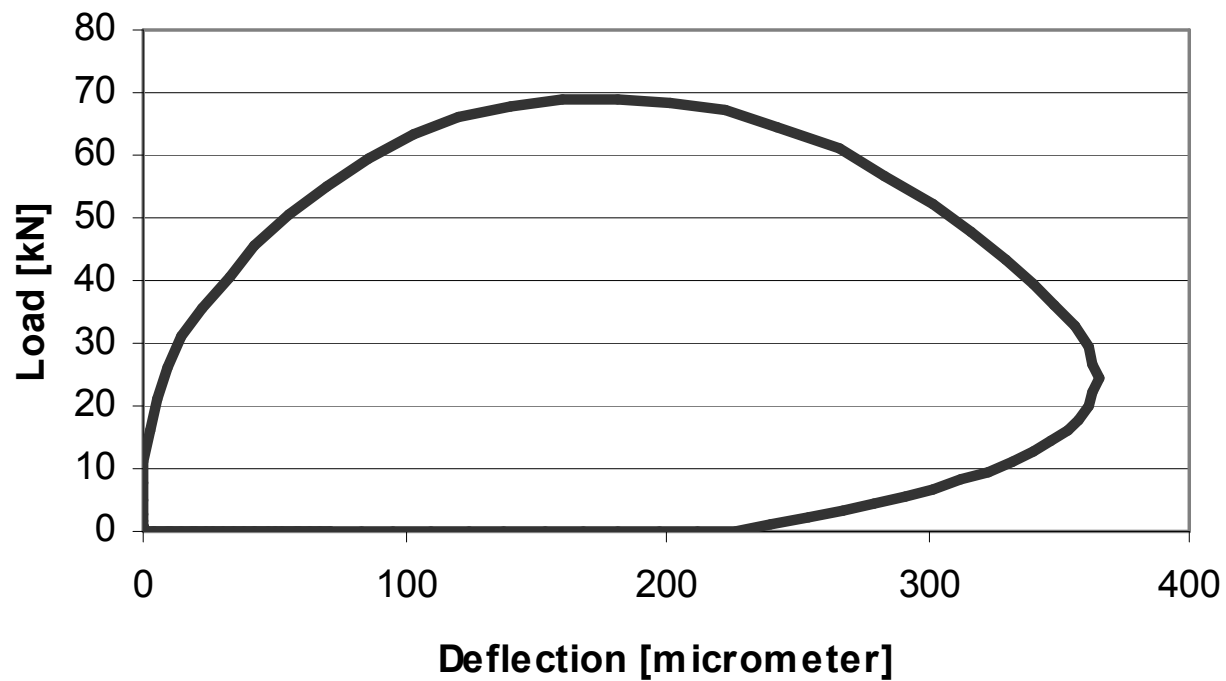
Example: 180 mm Thick Asphalt Concrete Load-Deflection Diagram at 40°C

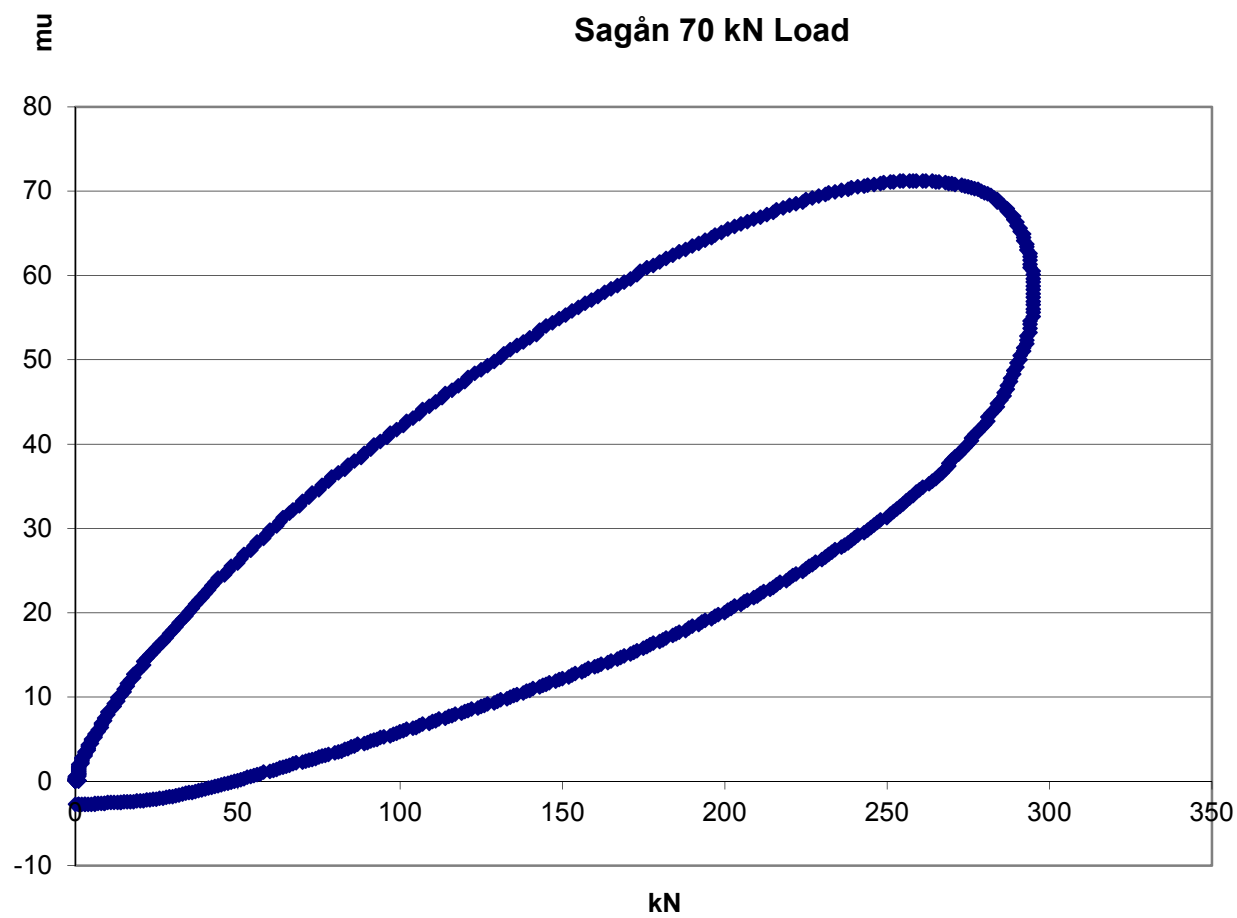
New 200 mm ACP @ 70 kN and
@ 10 degrees C

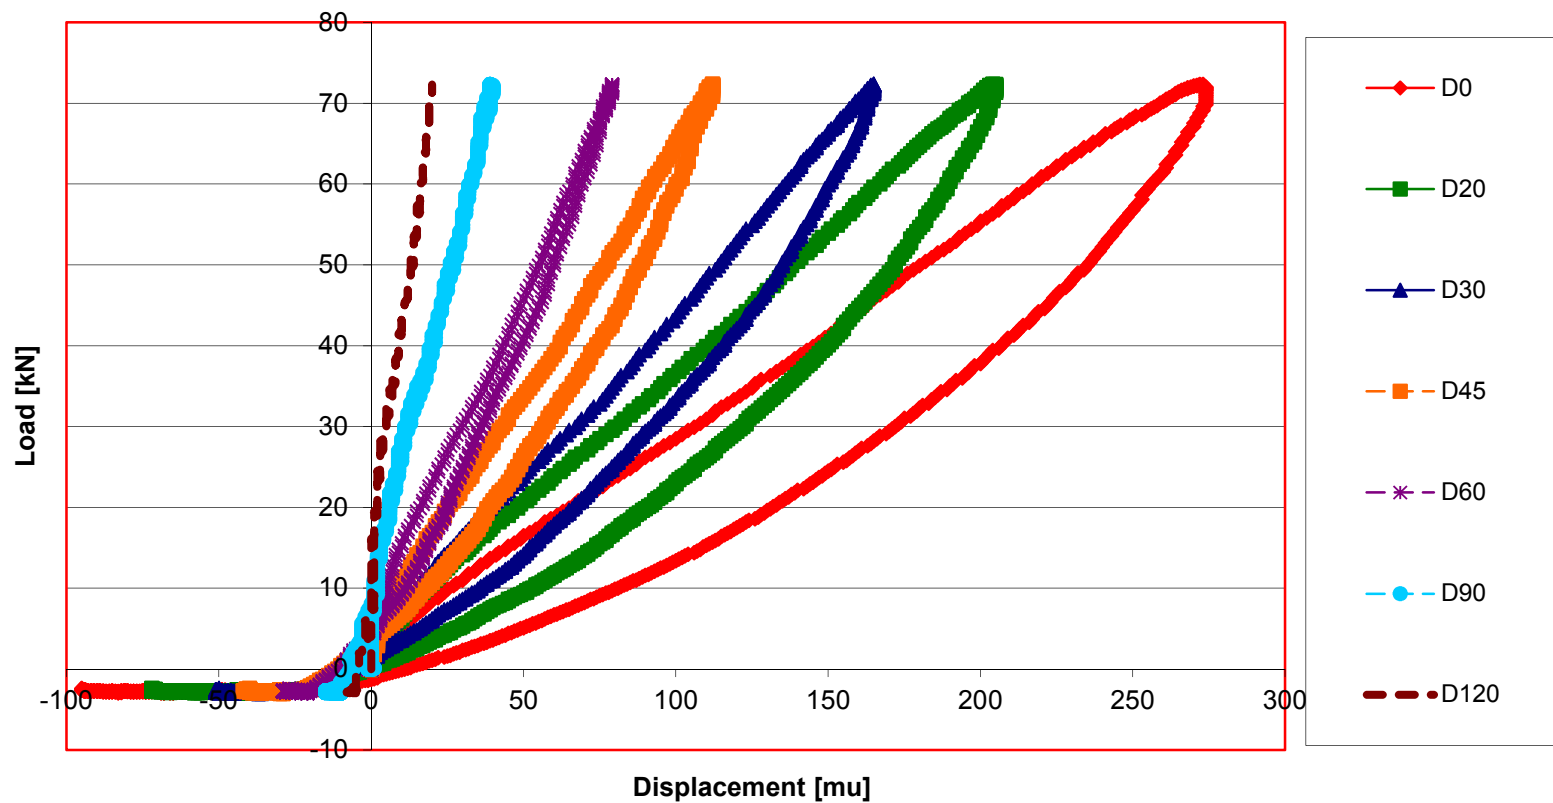
Intermediate 2-lane (new)

Hästbo Section: 2750 Drop: 10; Height: 4 Int 3863 mNm

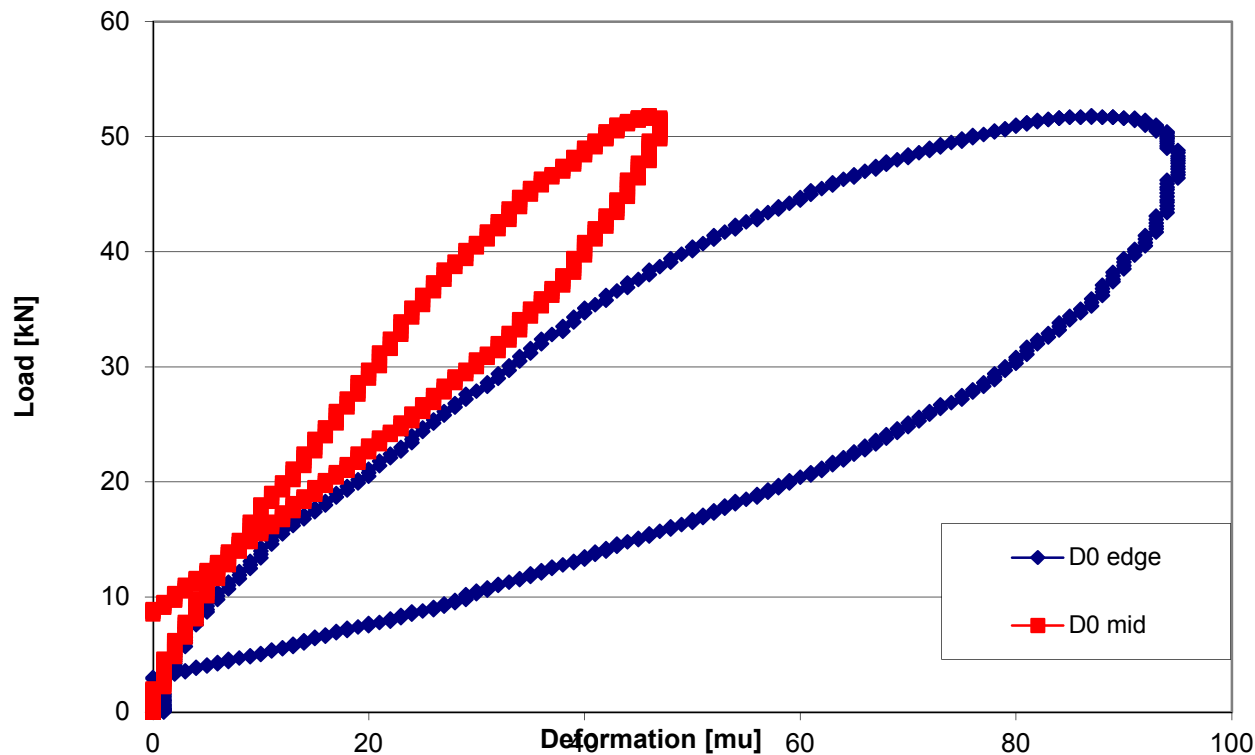
Effect of Curling Slabs

The edge effect was only apparent at the joint. → overall contribution estimated to about 10 % higher for the moving vehicle.

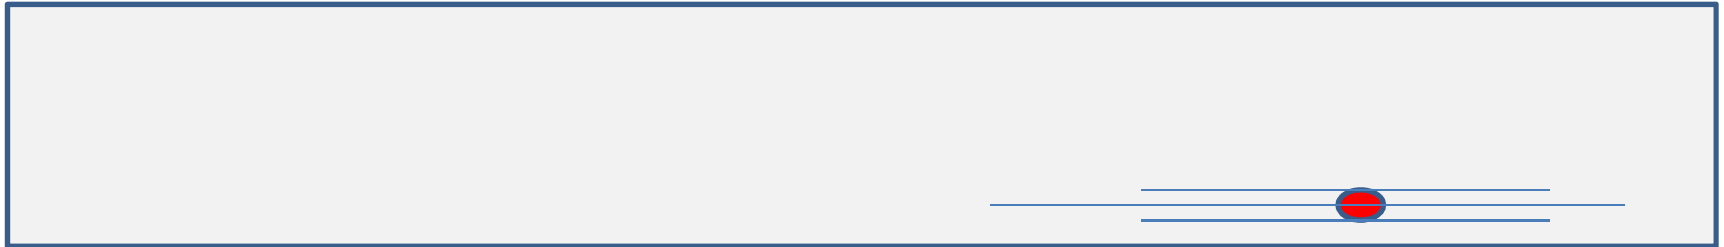
FWD Testing Layout

Three Lines along runway

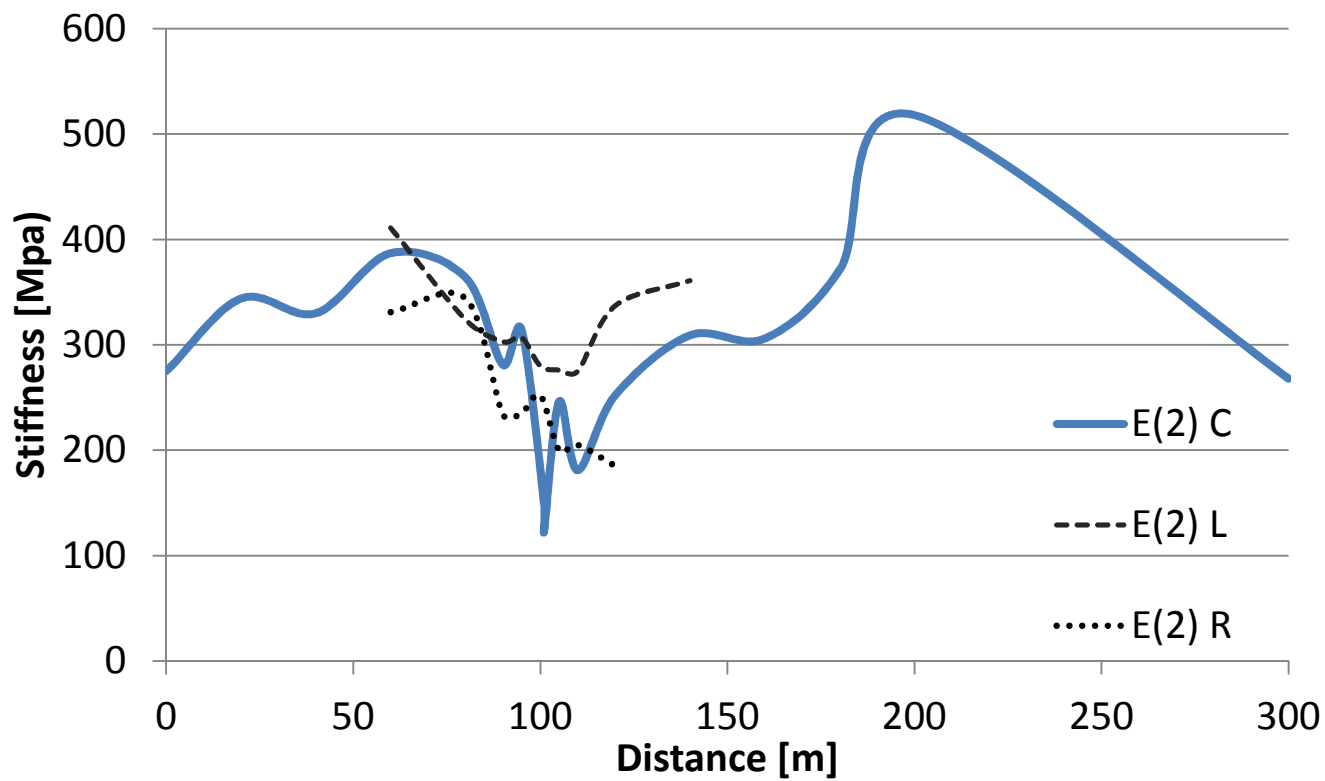
Unbound Layers

Certainly a drop of layer stiffness over settlement.

Difficult to assess reason, due to a combination of elastic and permanent deformations
